Reprinted from the MARCH/APRIL 1995 issue of

WHEN LIGHTNING STRIKES THE COMM CENTER

Protecting PSAPs from Lightning Devastation

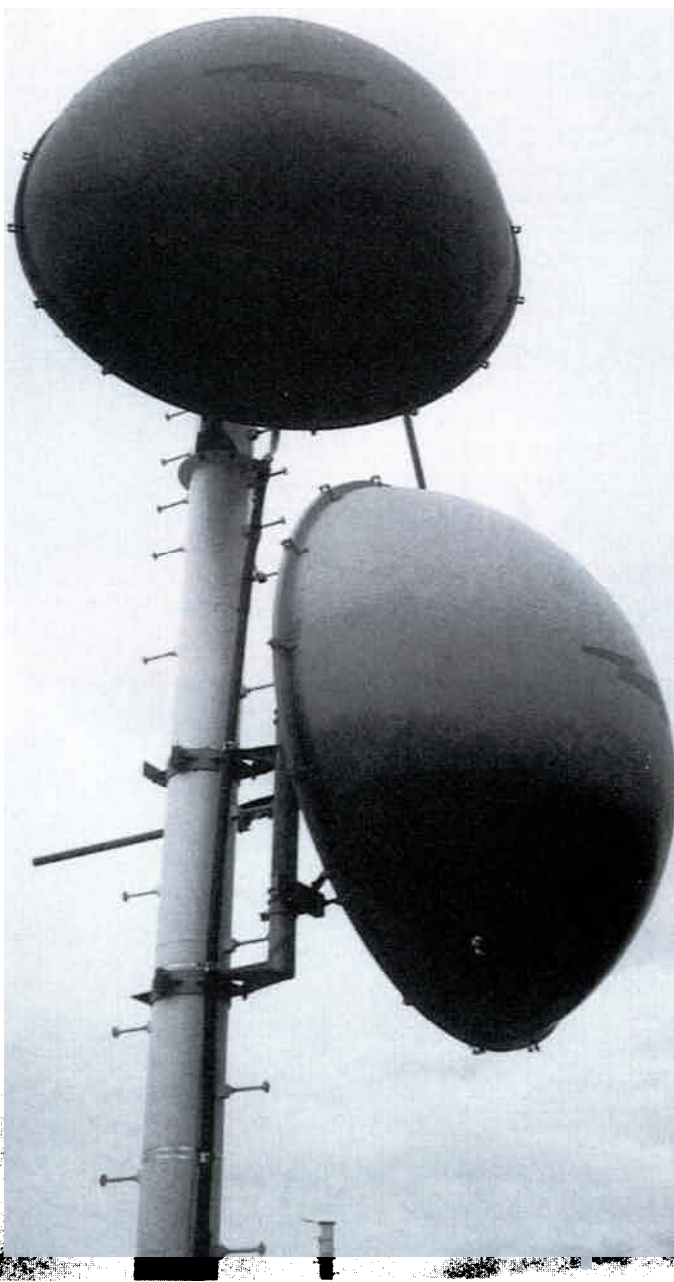
Microwave dishes are also potential targets for lightning strikes.

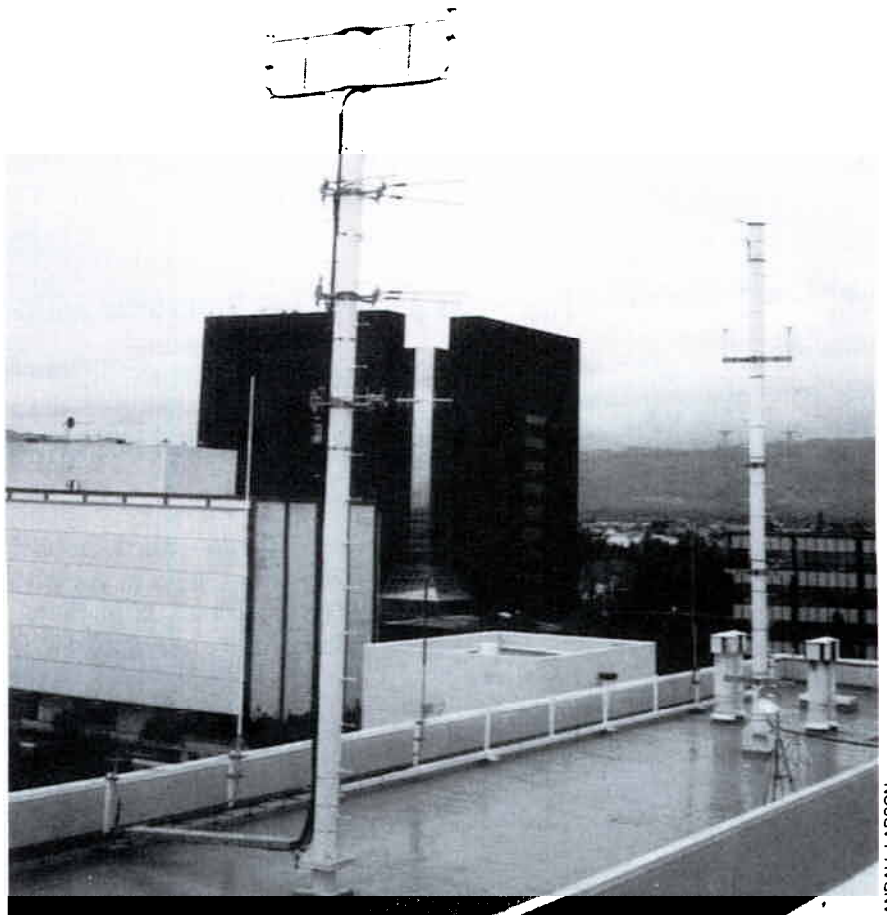
Public safety communications antennas are highly susceptible to lightning which can travel through the cabling and damage equipment or even injure the telecommunicator.

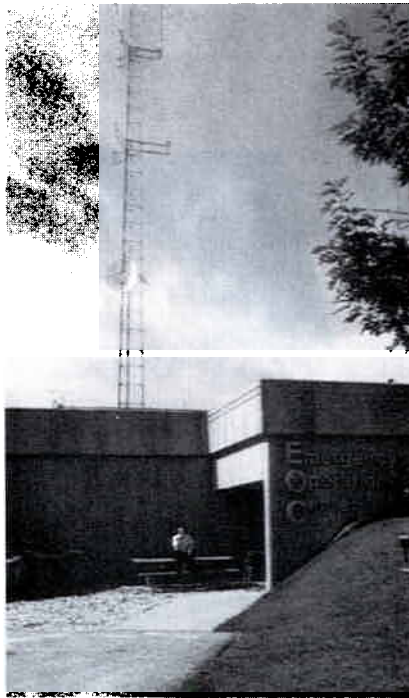
The Carroll County, Maryland, Communications Center was severely damaged by lightning in 1987. Installation of a Teleline Isolator effectively protected their equipment and personnel.

The solution to Carroll County's problem was a Teleline Isolator, which was installed by Positron in mid 1993. The Isolator is used as standard equipment by both telephone companies and power utilities to protect communication lines in high voltage environments such as electrical power substations. The Isolator breaks the copper continuity to eliminate the path of electricity so that no GPR current flows to the equipment. It does not allow the current to have a remote path to the ground. If the wires are permanently open then it is extremely unlikely for there to be equipment damage.

Since installation of the Teleline Isolator, Carroll County weathered one of the worst lightning storms to hit Maryland in 50 years. One storm knocked the entire area out of power. Across the street, the cable company was out and so was the PSAP down the road. Carroll County emergency center was struck by lightning but it sustained no damage.
